INSTRUCTOR TRAINING DIVISION
GENERAL INSTRUCTION DEPARTMENT
THE ARMORED SCHOOL
Fort Knox, Kentucky

MILITARY MONOGRAPH

TITLE: Armored Support of Infantry.

Robert W. Young

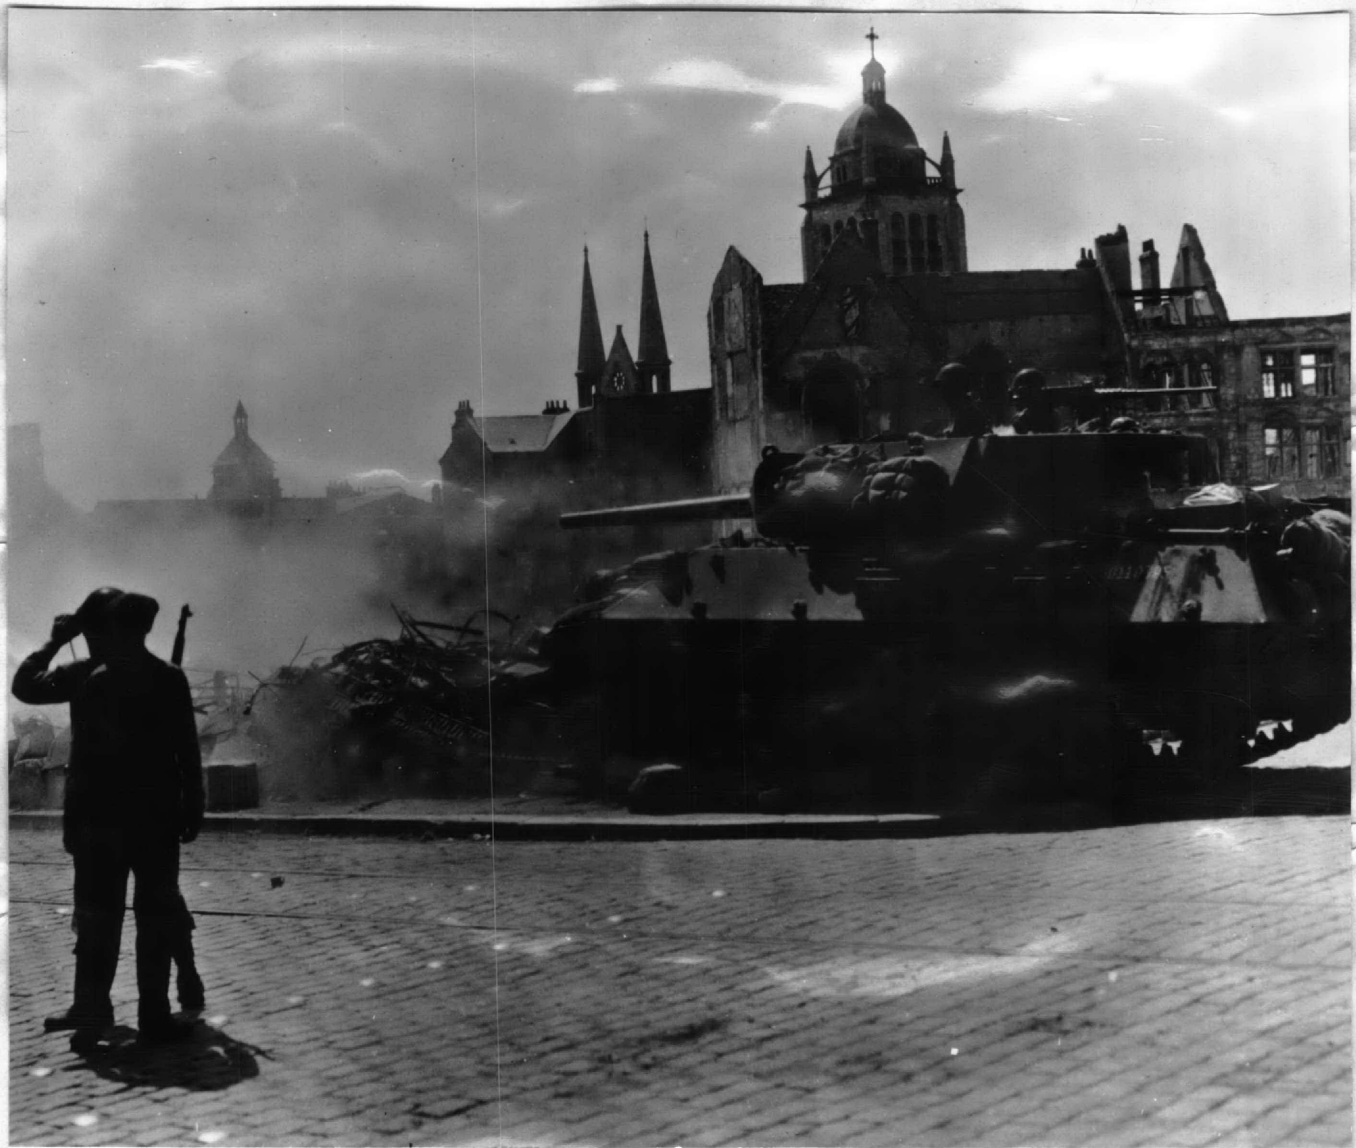
Direct Fire Mission

A three inch naval gun mounted on motor carriage, M10, performing a direct fire mission by a tank destroyer unit in World War II.

The gun he referred to was the three inch naval gun that had been modified and placed on a motor carriage, M10.

Thousands of these powerful units, quickly produced, helped to turn the tide against the Germans in Africa, Italy, and France. This gun motor carriage was made by mounting the three inch gun and recoil mechanism--initially designed for use on the heavy tank, M6--in a special turret on the M4 tank chassis. The design was completed and the vehicle standardized in July 1942. As mounted, the gun had a range of 16,000 yards, and with the armor-piercing ammunition available from the start, it could penetrate four inches of the best armor plate at 1,000 yards.¹

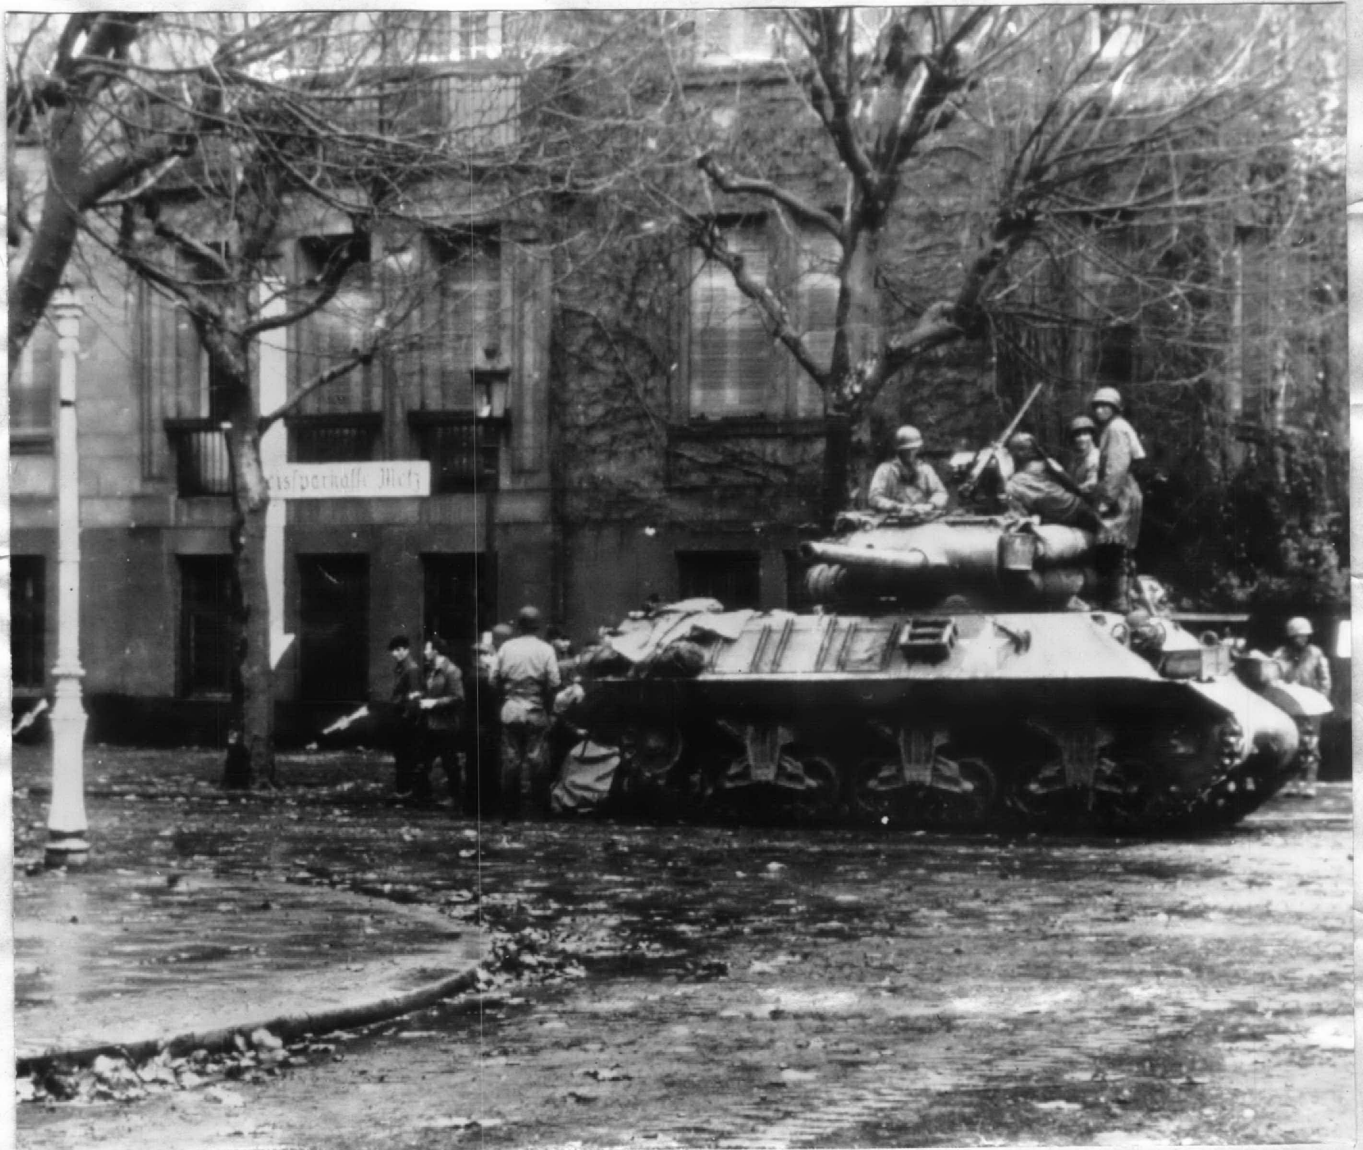
Antitank Mission

A tank destroyer mounting a 90mm gun takes up a position looking down Herman Goering Street in METZ, after the city was captured by allied forces.

The three inch gun proved its worth up to the Rhine River. While crossing the Rhine and during the defense of the Remagen bridgehead, the 899th Tank Destroyer Battalion was re-equipped with a new weapon, the 90mm gun mounted on the motor carriage M10, which had been provided a new turret in the process of conversion. It was now termed the M36. The 90mm, M3, gun used on this vehicle can penetrate 4.8 inches of armor with standard armor piercing capped ammunition, and 7.8 inches of armor with the high-velocity, tungsten carbide ammunition, at a range of 1,000 yards.
